Pilot Case Study Monograph Litzauer Schleife on Lech

Silke WIEPRECHT, Ianina KOPECKI

SHARE - Sustainable Hydropower in Alpine Rivers Ecosystems
<http://www.sharealpinerivers.eu>

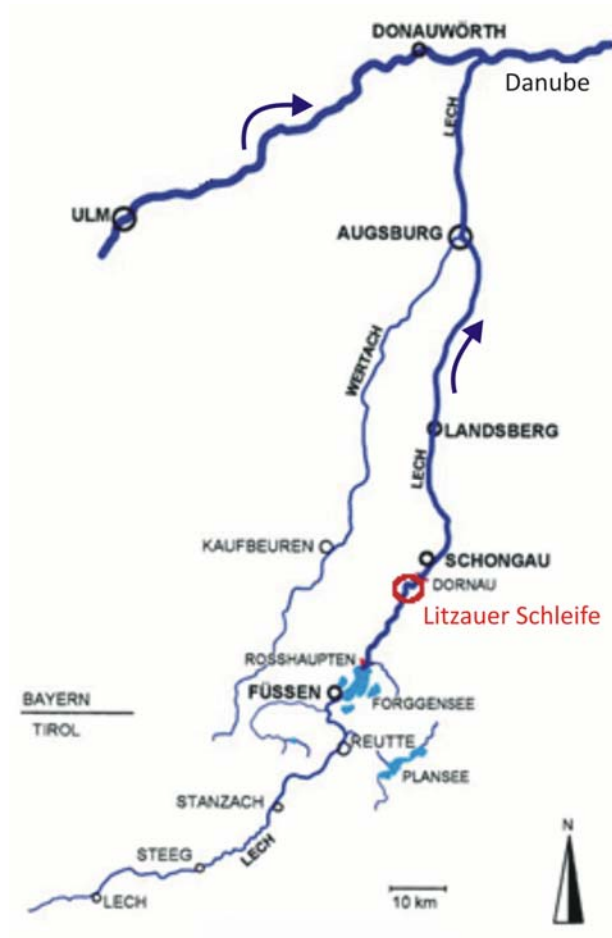
Figure 2. River Lech catchment; case study reach Litzauer Schleife

The river Lech is a right tributary of the river Danube with a total length of 256 km. Originating in the northern Limestone Alps in Tyrol, Lech passes the Austrian-German border near the town of Füssen and joins the upper Danube east of Donauwörth (see **Figure 2**). Its largest tributary is the river Wertach with the confluence at Augsburg. The important cities on Bavarian Lech are Schongau, Landsberg and Augsburg.

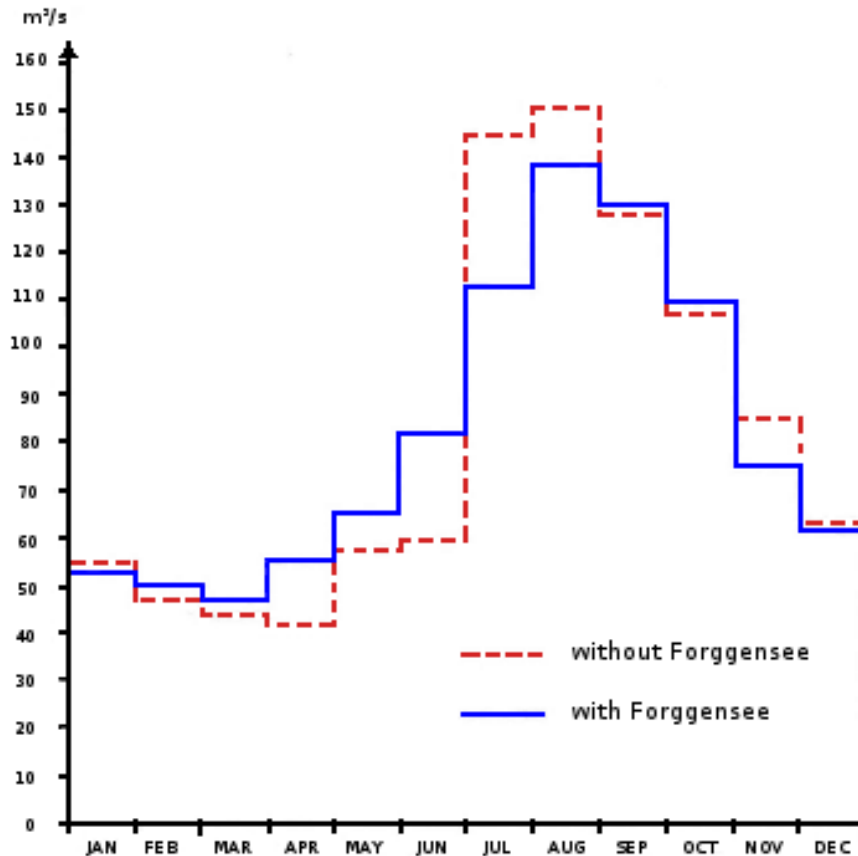
Figure 5. Average monthly discharges of Lech by Landsberg before and after construction of the head reservoir Forggensee, 1901-1953 and 1954-1980 time series.

The Bavarian part of Lech is fully developed for hydropower production. Consequentially, the hydrological situation in the Lech basin below Füssen is shifted to a considerable degree from a natural situation. An important Lech's hydropower chain component – the head reservoir Forggensee with an active storage of $135 \times 10^6 \text{ m}^3$, in operation since 1954 – provides the flow regulation on the annual basis. Although the Alpine character of Lech's runoff is not completely altered now, the annual distribution of monthly discharges is shifted to insure the needs of hydropower production, recreation and provide flood protection. The distribution of monthly discharges before and after construction of the head hydropower station Roßhaupten is shown in **Figure 5**. It can be seen that the regulated average discharges of May and June are reduced and those of December to April are considerably increased in comparison to the natural flow situation.

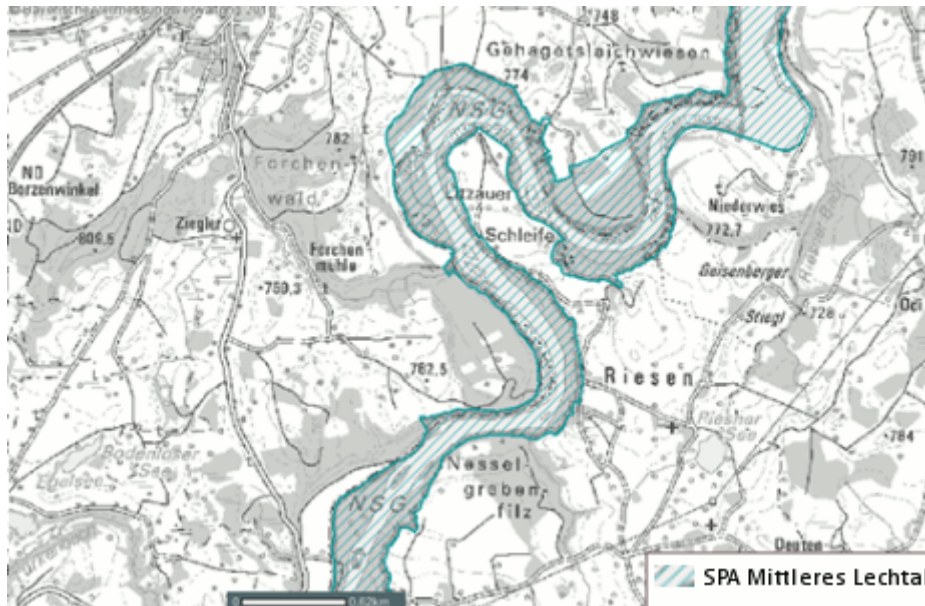
Figure 7. The borders of SPA “Mittleres Lechtal” in the area of Litzauer Schleife

- has been declared to the Bavarian state conservation area “Lechabschnitt Hirschauer Steilhalde - Litzauer Schleife” according to BNatSchG in 1986;
- constitutes a part of the NATURA 2000 Special Protection Area (SPA) “Mittleres Lechtal” (Code 8031-471, see **Figure 7** where the borders of the SPA within Litzauer Schleife are shown)
- and a part of the NATURA 2000 Site of Community Importance (SCI) “Lech zwischen Hirschau und Landsberg mit Auen und Leiten” (Code 8131-371, see **Figure 8** where the borders of the SCI within Litzauer Schleife are shown)

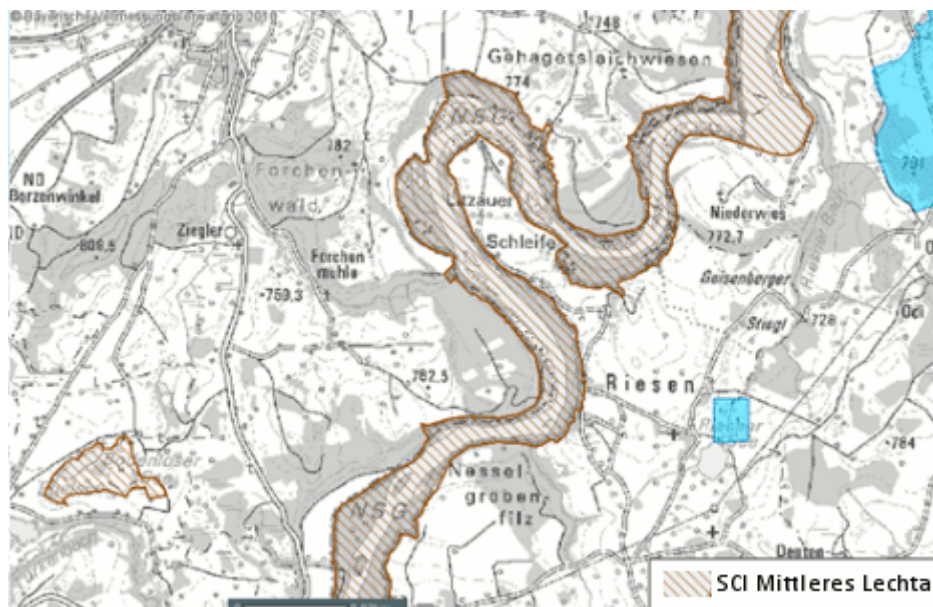
Figure 8. The borders of the SCI “Lech zwischen Hirschau und Landsberg mit Auen und Leiten“ in the area of Litzauer Schleife (coincide with the borders of the conservation area).

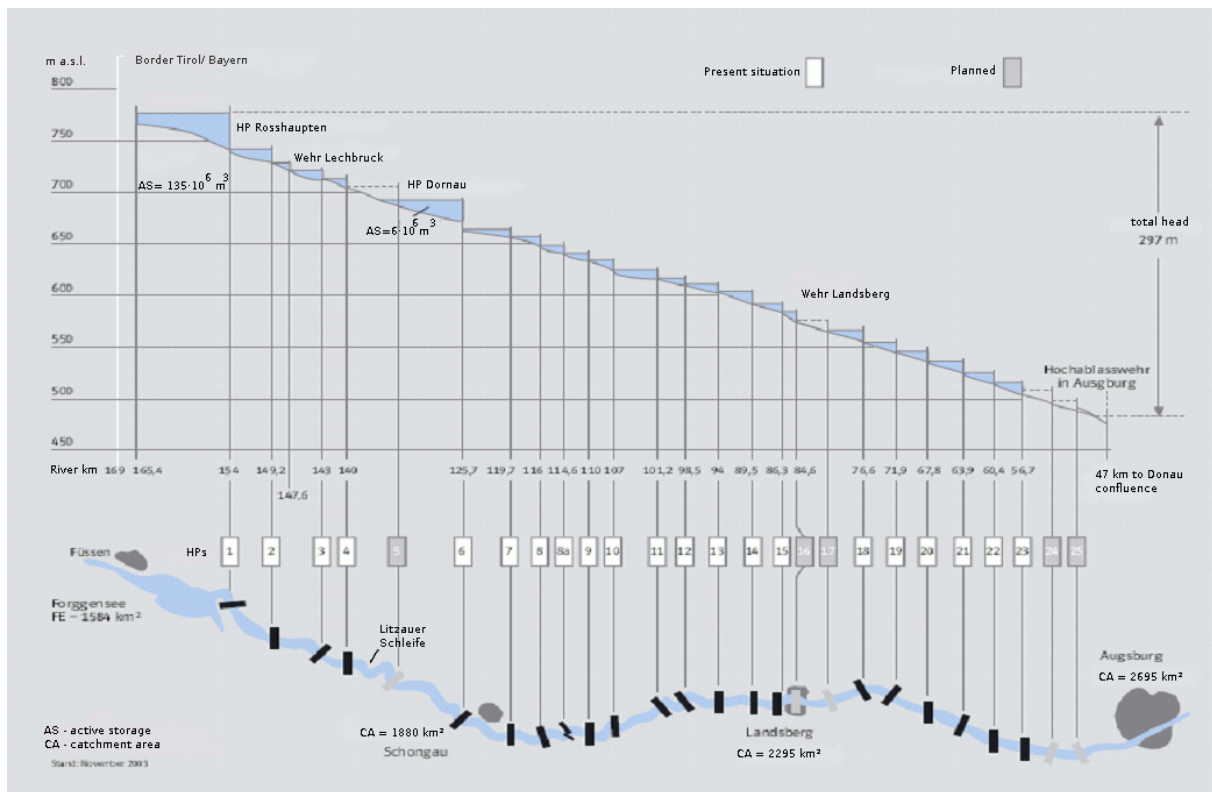
Figure 9. E.ON hydropower chain on Lech between Füssen and Augsburg

Wasserkraft Company, which owns twenty-two run-of-river plants and one storage power station on the Lech from Füssen to Augsburg (see **Figure 9**). This hydropower chain generates about 1,162 GWh of electricity per year on the back of an aggregate output of 258 MW. The hydropower stations on Lech below the city of Augsburg belong to two other companies – LEW (Lechwerke AG) and RMD (Rhein-Main-Donau AG) and have a total of 70 MW installed capacity. In **Table 4** the major characteristics of hydropower plants and weirs on the Middle and Lower Lech from Füssen to Rain are given. It can be seen that only one plant – HP Kinsau built in 1992 – is equipped with a fish pass, thus the longitudinal connectivity of Lech is completely broken up having a tremendous effect on the river ecosystem.

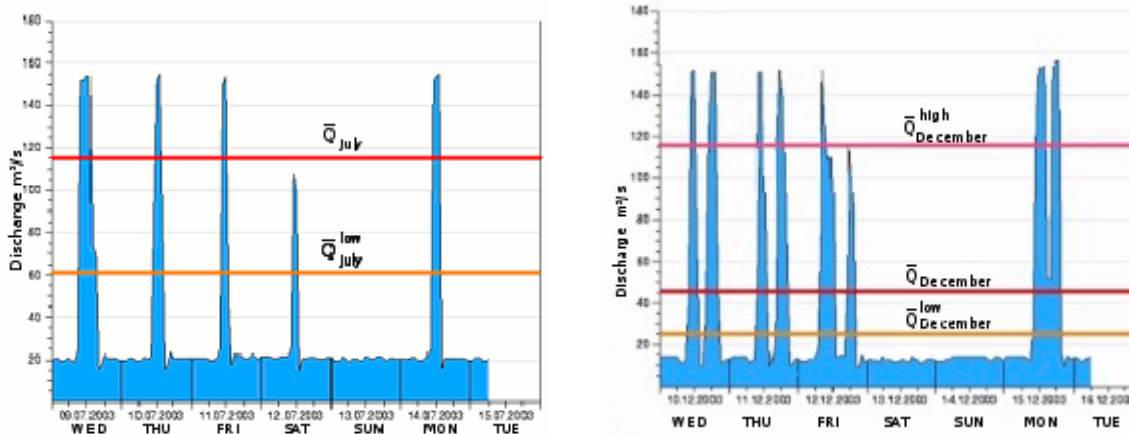
Figure 10. The typical summer and winter discharge situations during hydropeaking operation on Lech in 2003 [Schnell (2005)]

The typical discharge regulation situation in year 2003 for study reach is shown in **Figure 10**. It can be seen, that the base flow discharges in summer and winter are restricted to $20 \text{ m}^3/\text{s}$ and $10 \text{ m}^3/\text{s}$ respectively. The maximum hydropeaking flows exceed $150 \text{ m}^3/\text{s}$, both in winter and summer. In winter, two discharge peaks per day are usual.

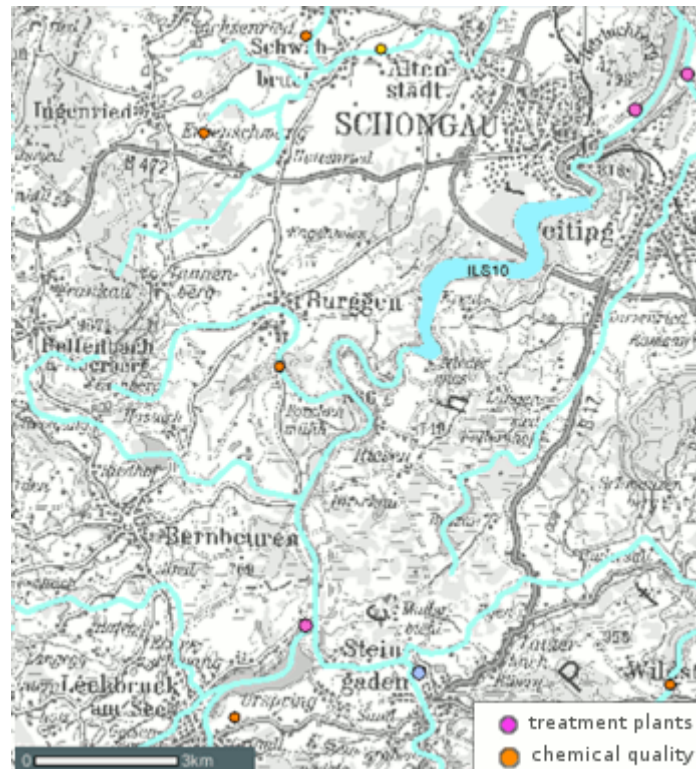
Figure 11. Waste water treatment plants in the area of the case study and chemical quality of flowing waters (status: good).

Waste water treatment stations in the close proximity to Litzauer Schleife study reach together with chemical water quality (status: good) are shown in **Figure 11**. The relevant stations upstream from Litzauer Schleife have following capacities (inhabitants number):

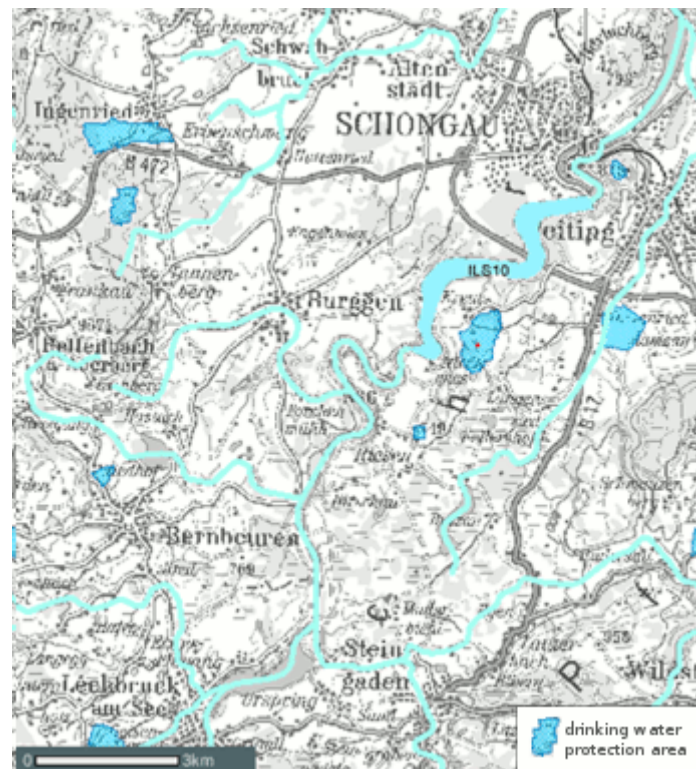
Figure 12. Location of drinking water protection areas in the case study area.

There are no drinking water supply points within the Litzauer Schleife reach itself. In the close proximity to the river on the right looking downstream there are two drinking water protection areas: Steingaden with an area of around 52 000 m² and Peiting M with an area of 720 000 m² (see Figure 12).
